TNR153513 – Electrolux Major Appliances Site - Inspection Photos

Project No.:	Site Location:	Permittee :	Date:	Time On-Site
TNR153513	Paul Lowry Road, 3,400 Ft. S. of TVA Allen Steam Plant, Memphis, Shelby County, Tennessee	Electrolux Major Appliances	June 20, 2012	09:00 AM

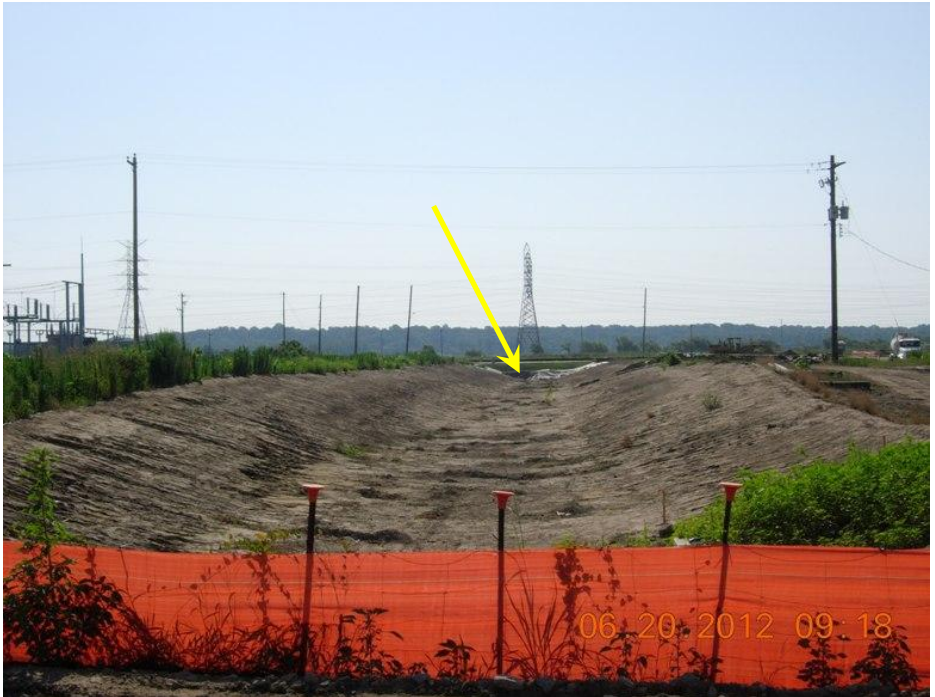
1	Cliff Caudle	
Description <p>View looking east down permanent diversion ditch DP-1. The geo-fabric lining had been removed to begin introducing vegetative stabilization to the ditch and banks. A berm had been constructed (arrow) at the downstream end of the ditch as an additional measure to ensure sediment doesn't leave the site via the ditch.</p>

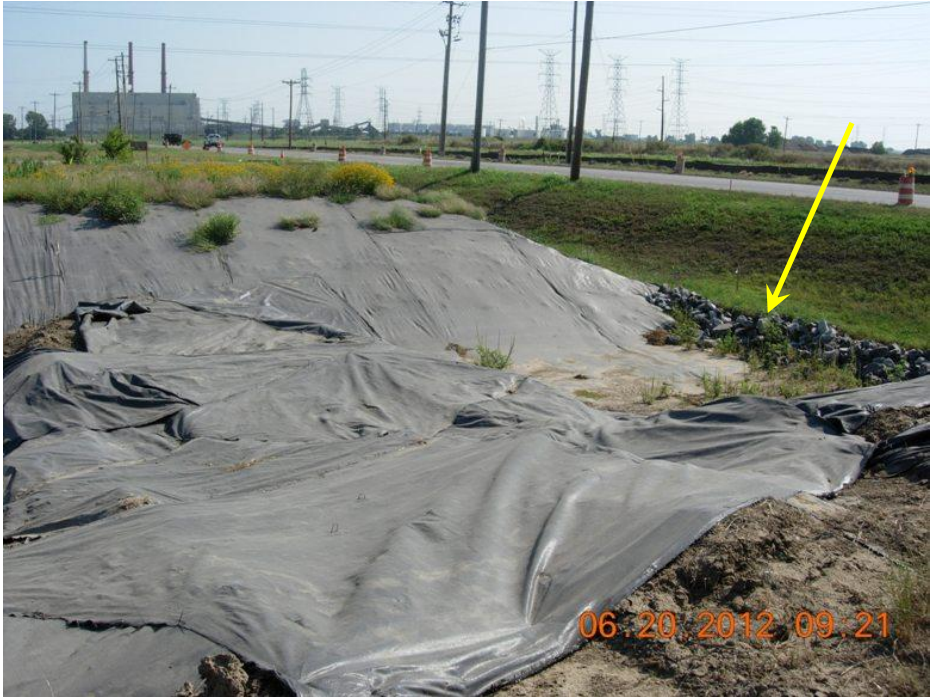
2	Cliff Caudle	
Description <p>Close-up view showing the berm referenced in photo 1. The berm and the existing rock check dam (arrow), were constructed to prevent off-site discharge of sediment and sediment-laden water via DP-1.</p>

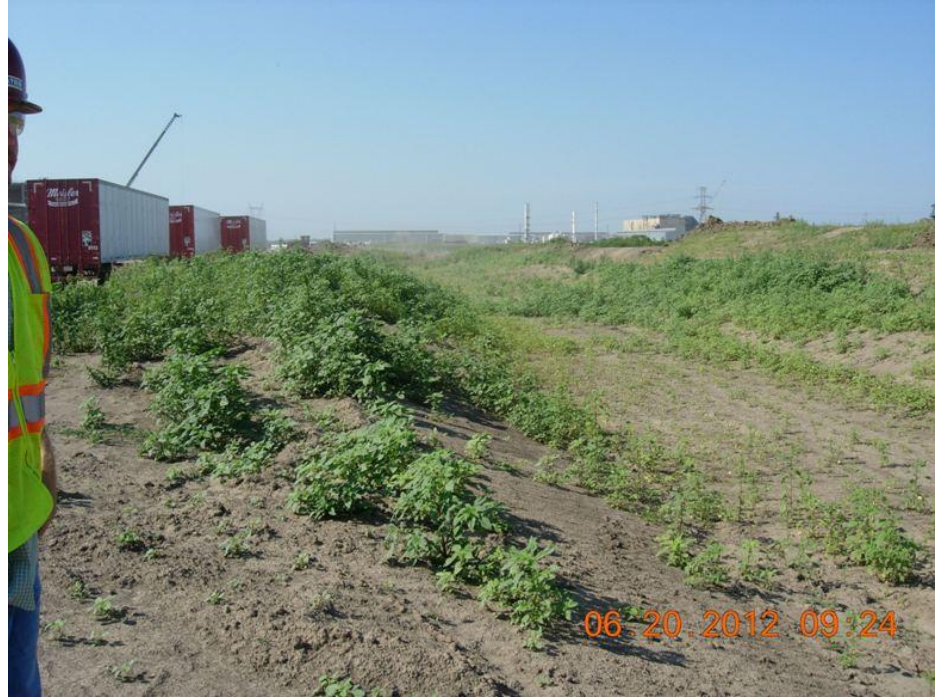
Photo No.	Photographer
3	Cliff Caudle

View looking south, down the newer north extension of permanent diversion ditch DP-2. A combination of bio-cover and natural re-vegetation had begun to partially stabilize the ditch.

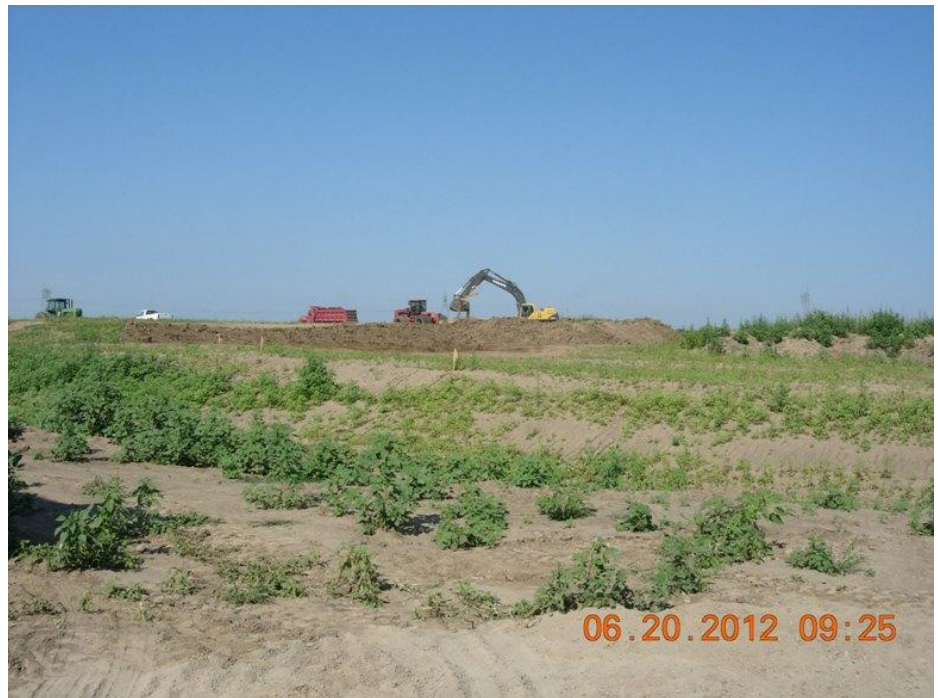
Photo No.	Photographer
4	Cliff Caudle

View looking southwest toward the temporary topsoil stockpile, which was being actively worked at the time of the inspection.

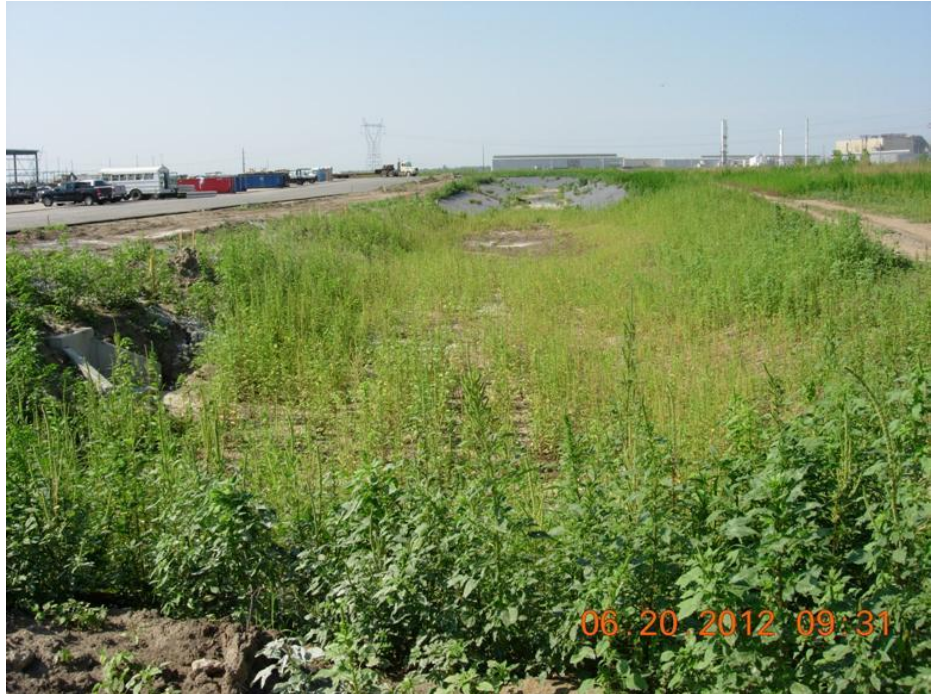
Photo No.	Photographer
5	Cliff Caudle

View looking southward down the western part of permanent diversion ditch DP-2. The geo-fabric lining had been removed from the originally-constructed part of permanent diversion ditch DP-2 on the western side of the building site, in order to begin introducing vegetative stabilization to the ditch and banks.

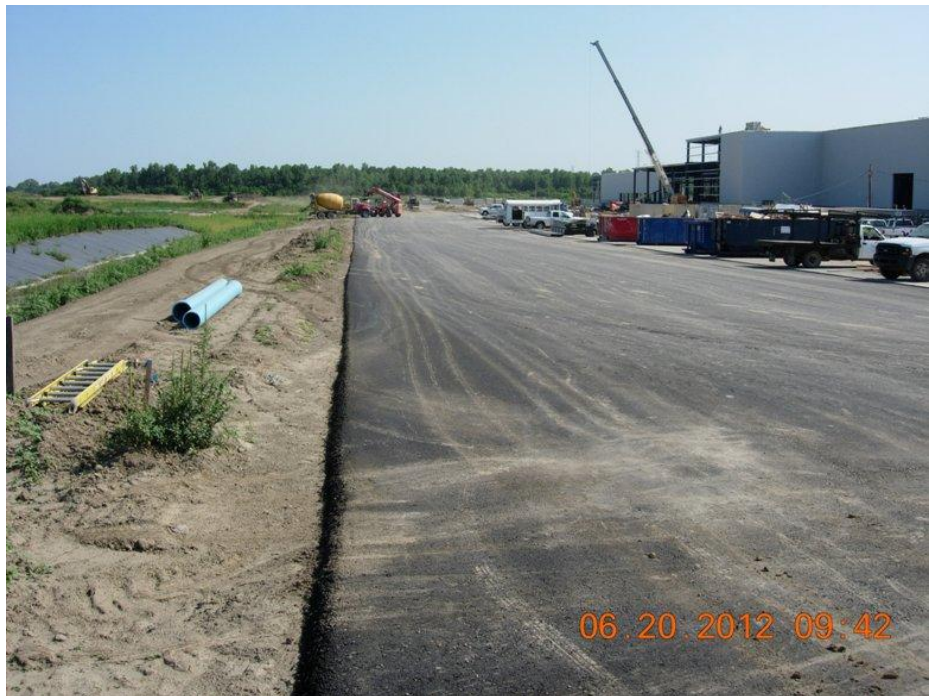
Photo No.	Photographer
6	Cliff Caudle

View looking northward along the western perimeter of the actual Electrolux plant construction area. The plant building and adjacent parking areas were largely complete with respect to ground disturbance. The soil area to the left had previously been stabilized with Bio-cover.

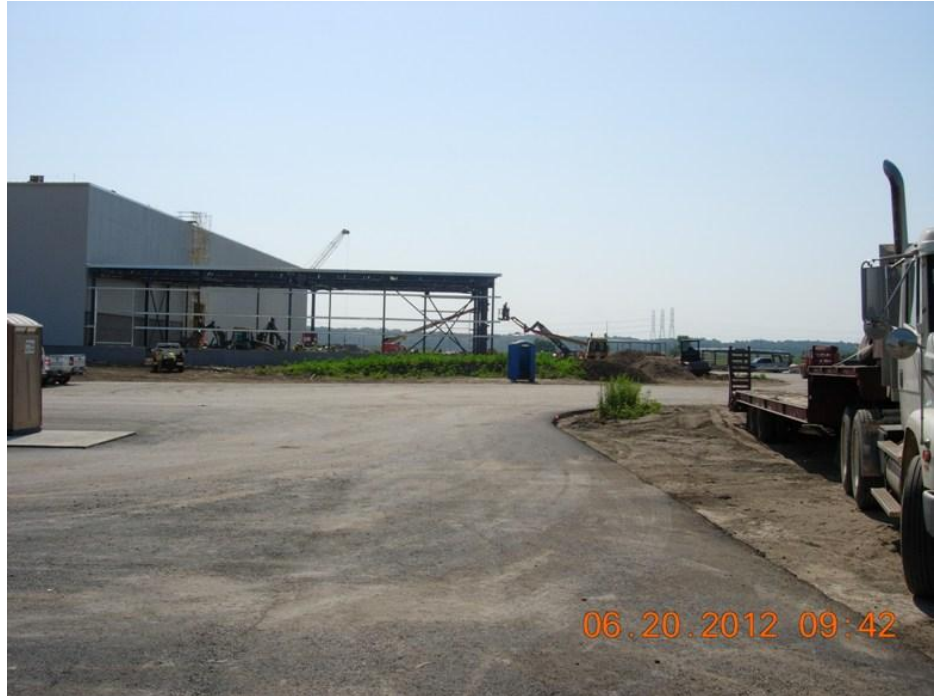
Photo No.	Photographer
7	Cliff Caudle

View looking eastward along the southern building perimeter. Parking areas and driveways were largely complete. Soil areas adjacent to the parking and drive areas had previously been stabilized with Bio-cover.

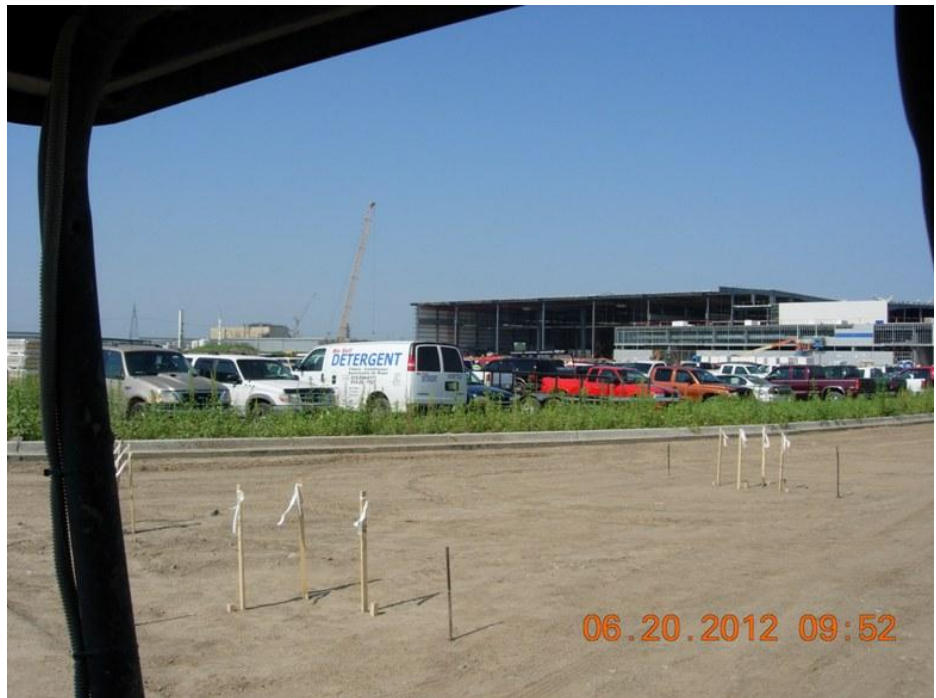
Photo No.	Photographer
8	Cliff Caudle

View southwestward from near the main entrance, showing the Electrolux building in the background and the large completed parking lot in use (cars). A second large parking lot, shown in the foreground, had been stabilized with soil cement in preparation for asphalt paving at the time of the inspection.

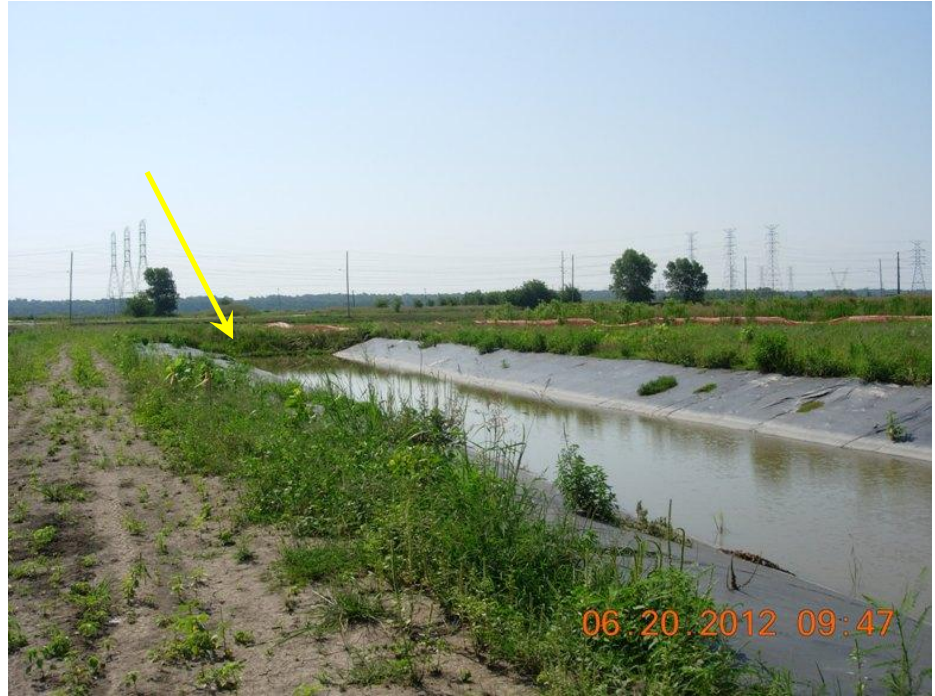
Photo No.	Photographer
9	Cliff Caudle

View looking eastward down the southern part of permanent diversion ditch DP-2. The geo-fabric lining had been removed from upper portions of DP-2 to begin introducing vegetative stabilization to the ditch and banks. Eventually all of DP-2 will be stabilized with perennial vegetation. A berm had been constructed (arrow) at the downstream end of the ditch as an additional measure to prevent off-site discharge of sediment and sediment-laden water via DP-2.

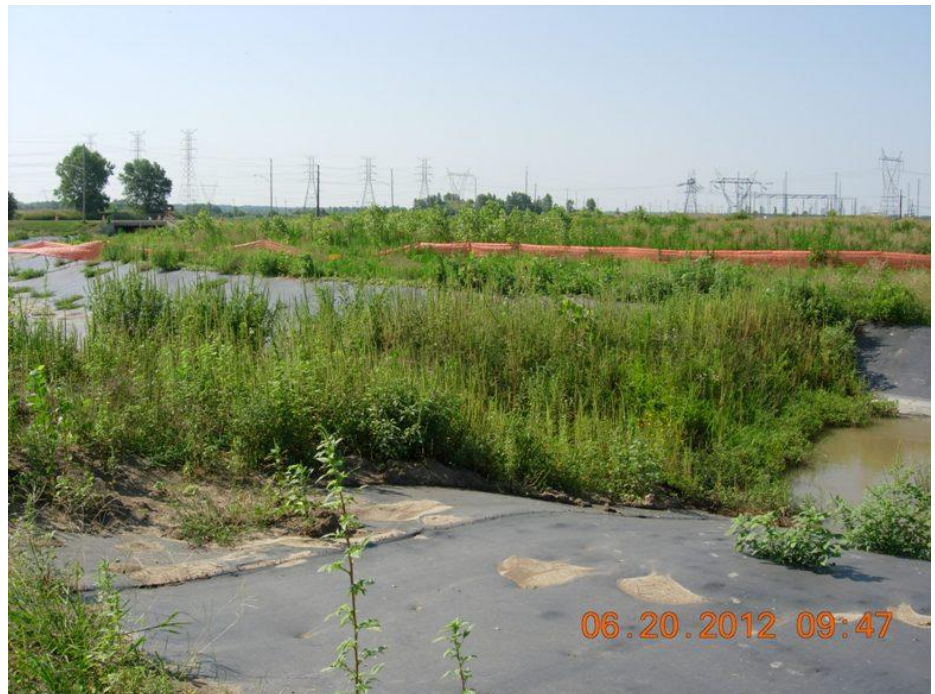
Photo No.	Photographer
10	Cliff Caudle

Close-up view of the berm shown in photo 9. The berm is an additional measure to prevent sediment and sediment-laden water from discharging off-site via DP-2.

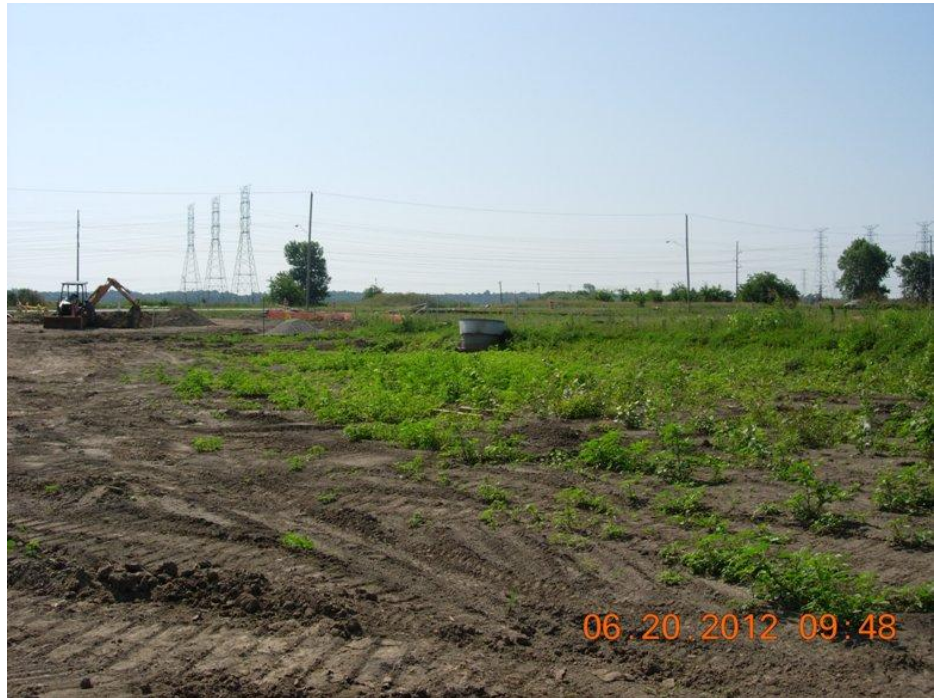
Photo No.	Photographer
11	Cliff Caudle

View looking southeastward from inside sediment basin #2, toward the basin discharge riser. No water was in basin #2 at the time of the inspection. Overall, the basin system appeared to be well-managed and functioning as planned.

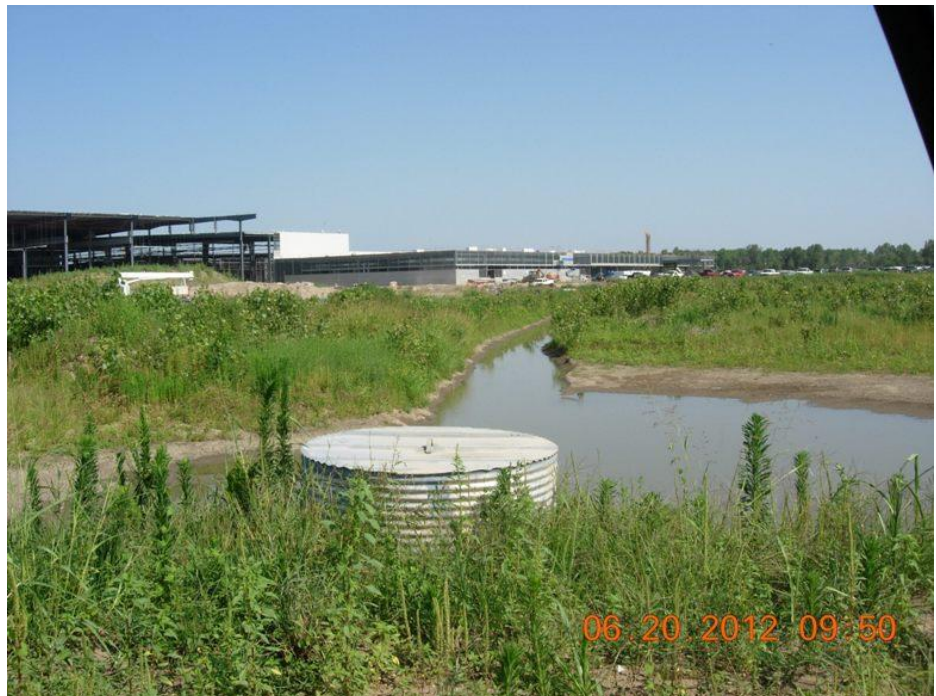
Photo No.	Photographer
12	Cliff Caudle

View looking northwestward from the levee of sediment basin #1, across the basin #1 discharge riser. The basin was not discharging at the time of the inspection. Overall, the basin system appeared to be well-managed and functioning as planned.
